Analysis of MQXFA07 Test Non-Conformity

US-HiLumi-doc-4293

Date: Sept. 12, 2022

US HL-LHC Accelerator Upgrade Project

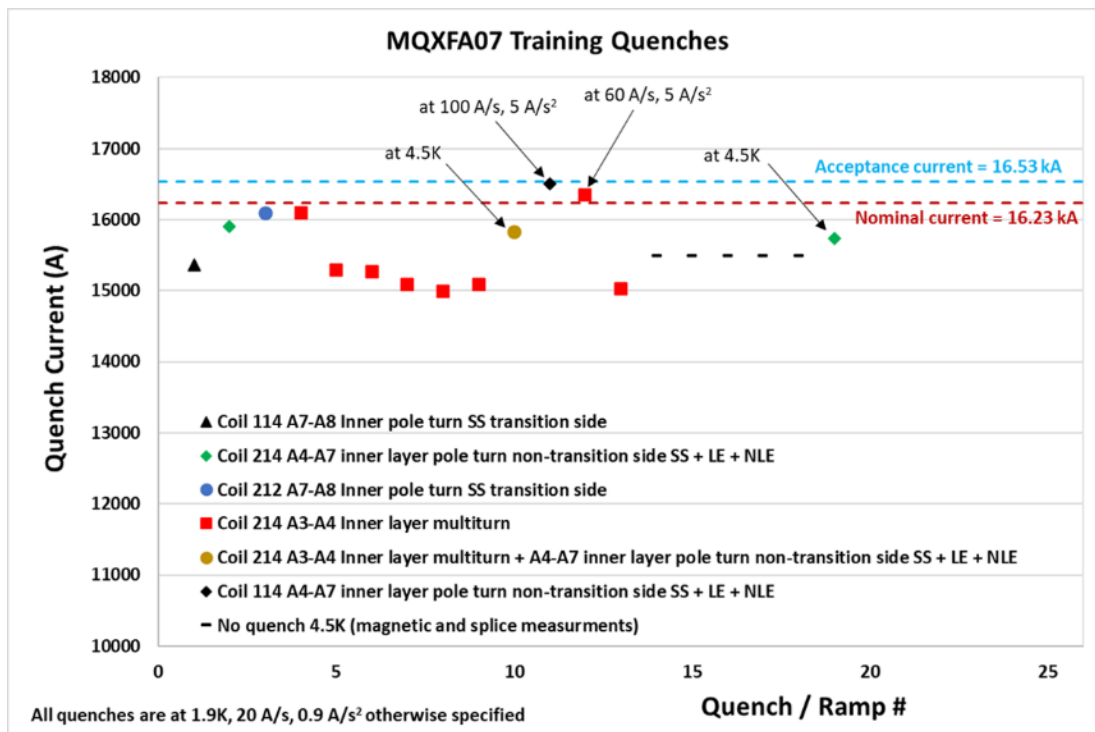
- reverse temperature dependence (higher quench current at 4.5 K than at 1.9 K, with standard 20 A/s ramp rate), with about 800 A increase at 4.5 K
- and reverse ramp-rate dependence (higher quench current at ramp rate higher than 20 A/s, at 1.9 K) with 1486 A and 1332 A increase at 100 and 60 A/s respectively, using the last quench at 20 A/s as reference.

Figure 2.1: MQXFA07 quench history

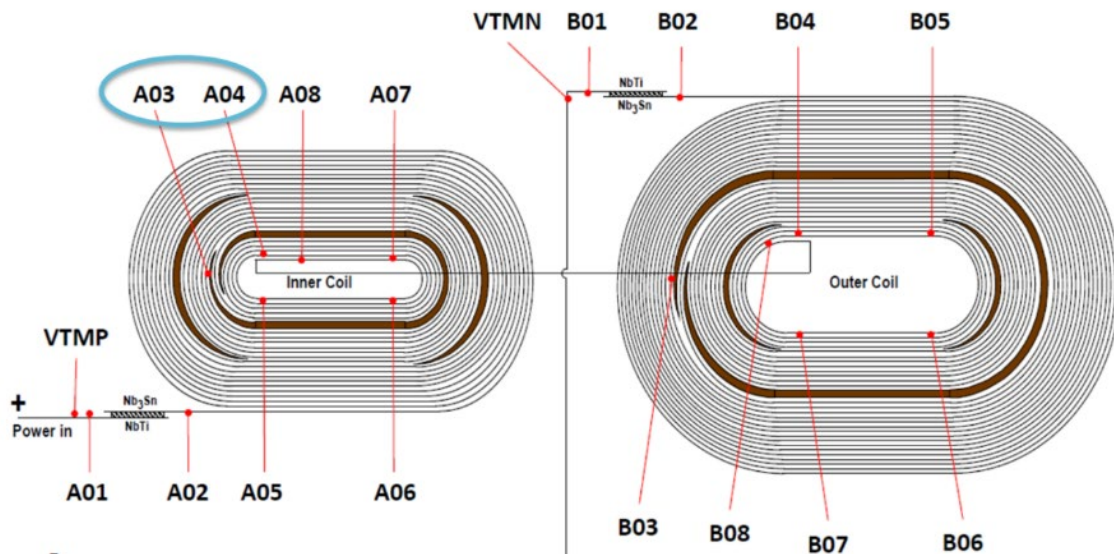
All limiting quenches in coil 214 started within segmented A3-A4 on the inner layer. As shown in Fig. 2.2, this is a multiturn segment including turns 2 to 6 counting from the pole. Turns 2-5 are included in the pole-block multiturn, whereas turn 6 is the first turn outside the wedge.

Figure 2.2: Voltage taps in MQXFA pre-series coils. All limiting quenches in coil 214 started with the multi-turn segment A03-A04.

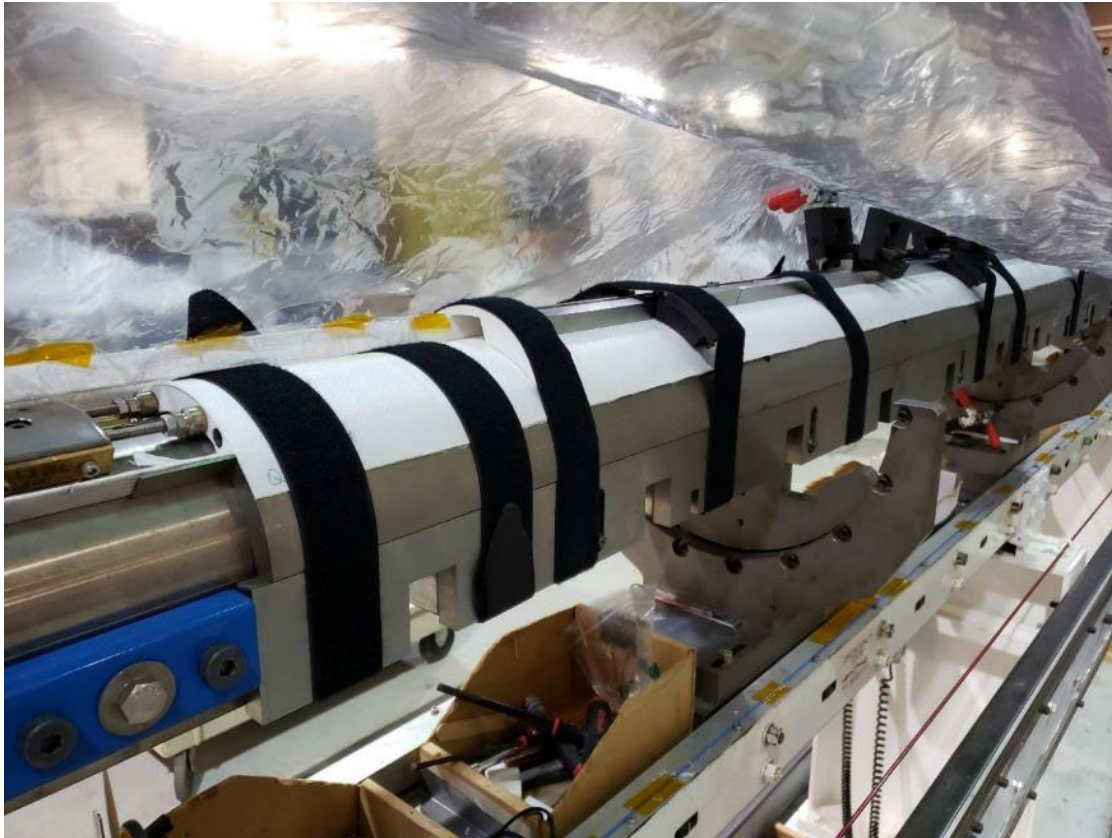
Usually the outer layer of a coil is wound and cured a few days after the inner layer. Subsequently, the tensioners keeping the coil stretched are removed. During the 14 weeks when coil-214 inner-layer was in storage with tensioners on, the bonding between wedges and end-spacers may have degraded.

Figure 3.1: coil 214 as it was setup for the lab shutdown

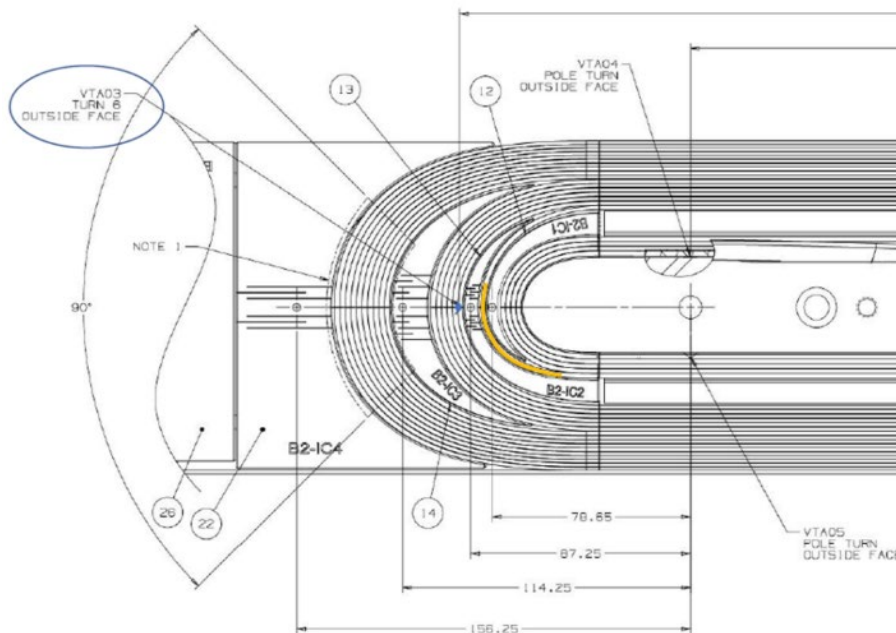
DR AM-164 describes that “during winding of layer 1, approaching turn 6, the cable collapsed”. The cable was repaired following standard practice (see details in Fig 3.2), and winding was resumed. “The next morning it was noted that some strands were out of position at the lead end.”

Figure 3.3: Inner layer coil drawing showing in yellow the position of coil-214 cable affected by DR AM-164

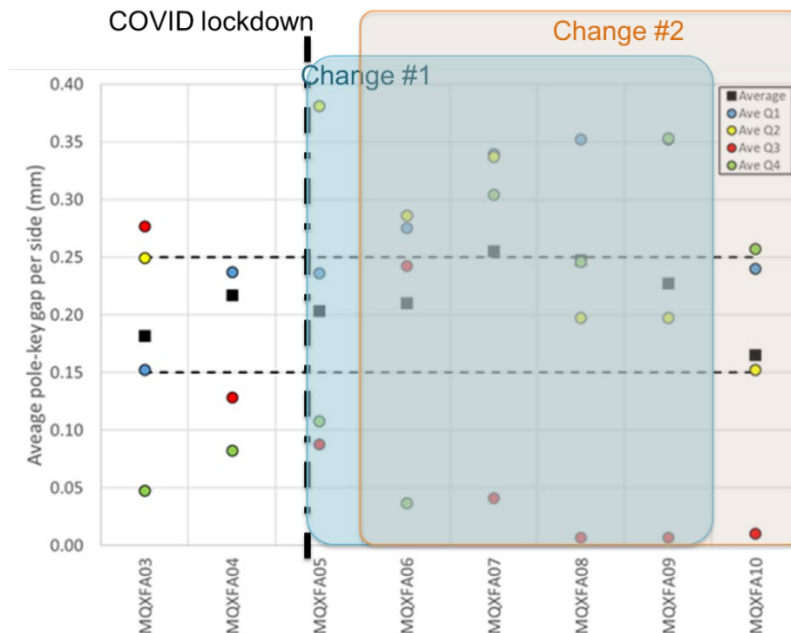
Figure 3.8: Average pole-key gaps (per key side) in magnets MQXFA03 to MQXFA10.

Figure 3.8 shows the average pole-key gap in each quadrant and for each magnet from MQXFA03 to MQXFA10. It can be noted that the minimum pole-key gap had a positive trend in magnets MQXFA03-MQXFA05, whereas it showed a negative trend starting with MQXFA06 (i.e. when change #2 was implemented). Therefore, it is our understanding that the changes due to Covid requirements contributed to small pole-key gaps in quadrant 3 of MQXFA07 and MQXFA08, which did not meet test requirements. Magnets MQXFA09 and MQXFA10 were disassembled before test, and MQXFA10 met test requirements after it was re-assembled with uniform pole-key gaps.

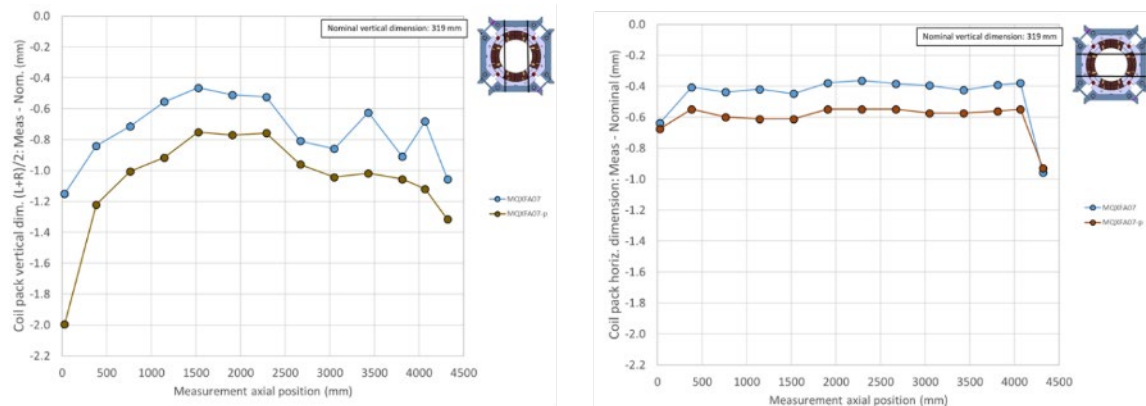
After unloading and disassembly, the coil-pack dimensions were measured and compared with the values taken during the first assembly (before the test). From A07 (before the test) to A07p (after the test) the coil-pack reduced in size by 0.2 to 0.3 mm (see Fig. 4.1).

Figure 4.1: Coil-pack dimensional measurements before the test (A07) and after the test (A07p).

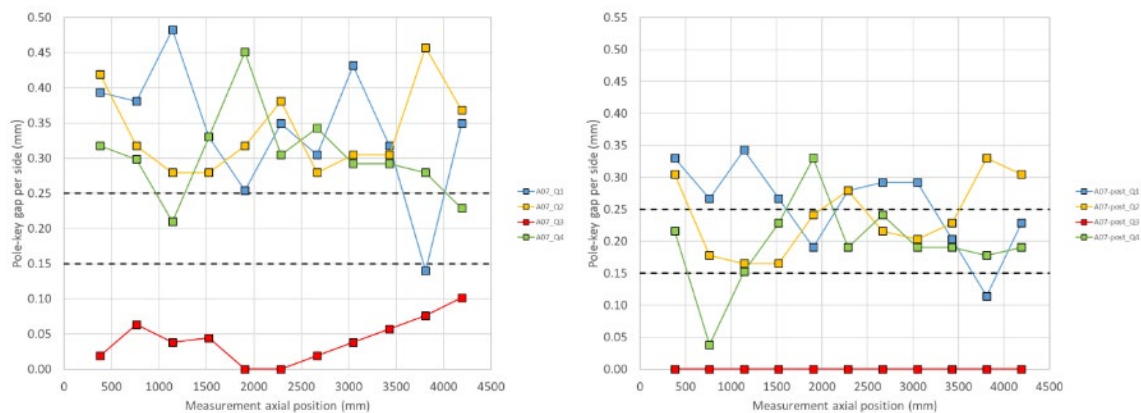
Consistently with the trapezoidal shape of the coil pack, a non-uniformity in the distribution of the pole key gaps was observed, both before and after the test. In Fig. 4.3, the pole key gap measurements in each quadrant as a function of the axial position, before the test (A07) and after the test (A07p), are shown. The specifications for the pole gaps, indicated by the dashed lines in the figures, state that the average pole key gap (per side) among the four coils on each longitudinal location shall be $+0.200 \pm 0.050$ mm. It can be seen that the average among 4 quadrants is on spec, both before and after the test, but a significant variation among quadrants is present. In particular, in Q3 an extremely low gap is observed before the test, and it becomes null after the test. The measurements before and after the test show that the gaps decreased by about 0.100 mm, but the same profiles among the quadrant is maintained, demonstrating the neither the room temperature loading, nor the cool-down or the test, corrected the non-uniformities in the pole key gaps.

Figure 4.3: Pole key gap measurements in each quadrant as a function of the axial position, before the test (A07) and after the test (A07p). The dashed lines indicate the spec values of the average of among the four quadrants on each longitudinal location.

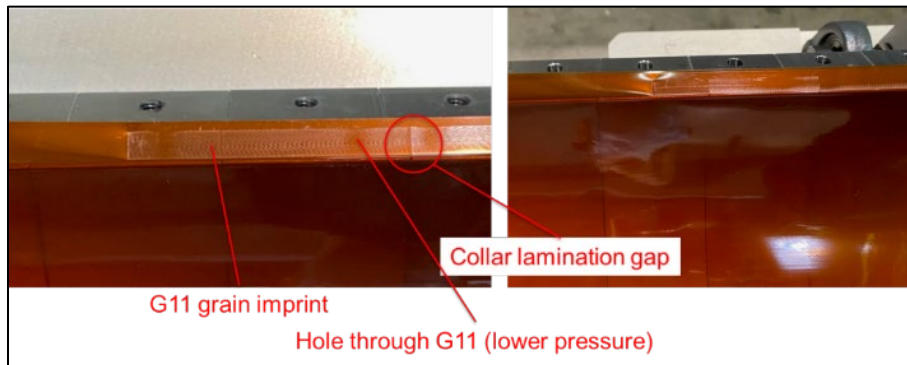
After the coil pack-disassembly, coils, ground isolation layers and pole keys were inspected. In quadrant 3, deep imprints in the Kapton indicating collar lamination lines, G11 grain, and “lower pressure” spots at every hole in the G11 keys (Fig. 4.4). These imprints, all indicative of a higher pressure, were not seen in the other quadrants. In addition, the G11 keys in Q3 also showed high pressure “imprints” of collar lamination gaps (Fig. 4.5), not observed in the other quadrants.

Figure 4.4: Imprints in the Kapton of Q3: collar lamination lines, G11 grain, and “lower pressure” spots at every hole in the G11 keys.

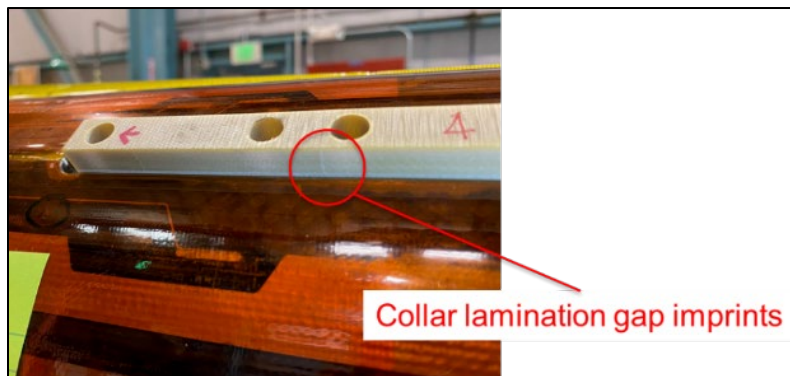
Figure 4.5: High pressure “imprints” of collar lamination gaps in the pole keys of Q3.

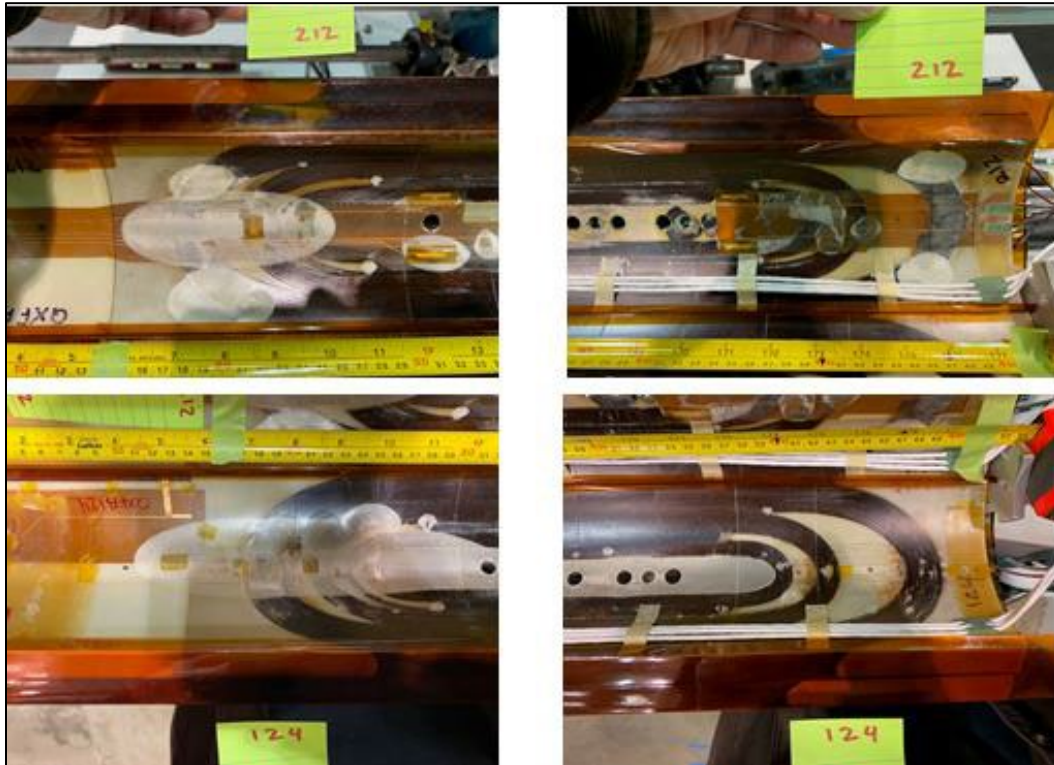
The coil inner surface was characterized by many bubbles/blisters, predominantly on the LE (Fig. 4.6 and 4.7). More observations and comments may be found at section 6.1 “Coil 214 Visual Inspection”.

Figure 4.6: Inner surface of coil 212 and 124 in the end region after test.

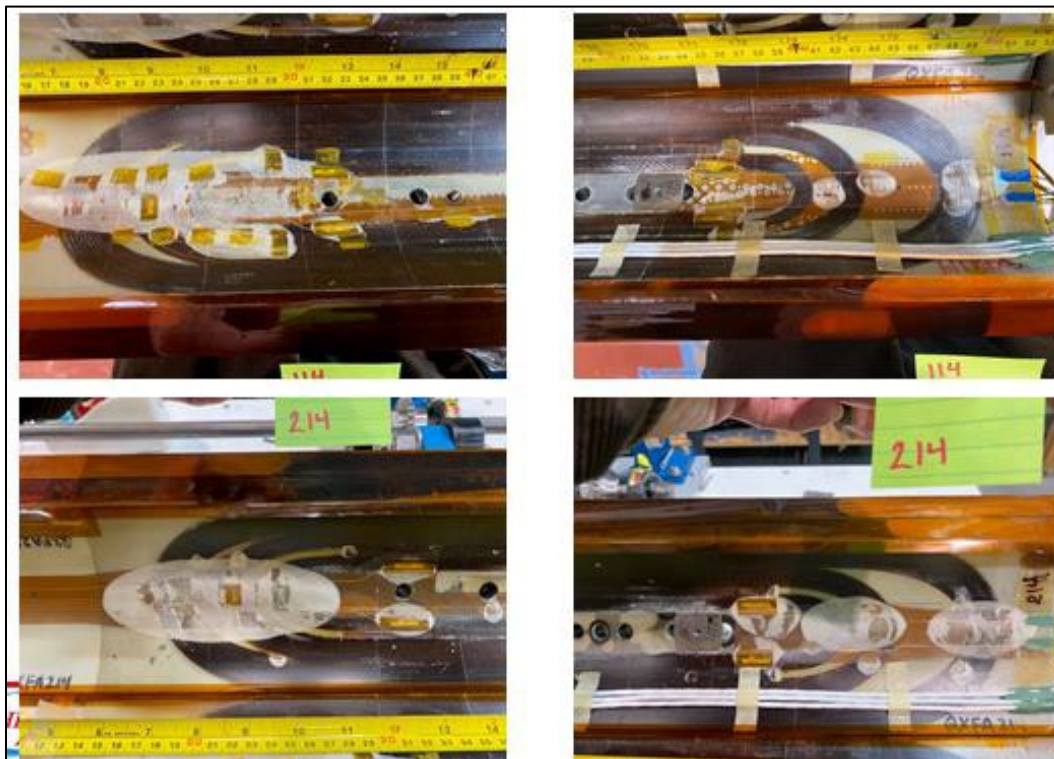
Figure 4.7: Inner surface of coil 114 and 214 in the end region after test.

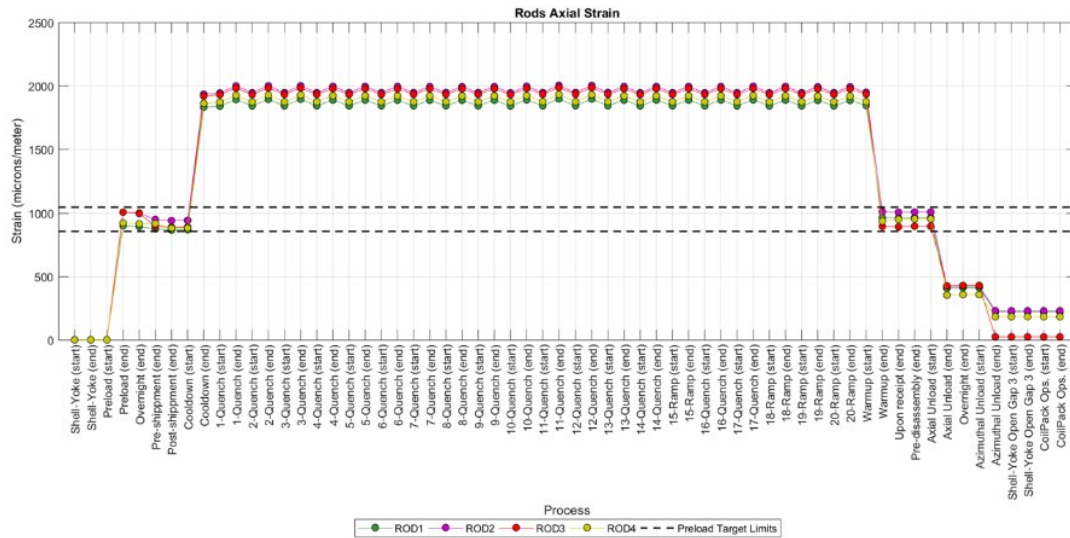
However, it was observed that the nuts on rods 1, 2, and 4 all were loose after the 2nd step (Rod 3 remained snug). Therefore, a slight tension (increase of $\sim 25 \mu\epsilon$) was added to these rods before proceeding to fully unload the azimuthal preload.

In addition, a residual strain in rods 1, 2, 4 of about $\sim 200\text{-}300 \mu\epsilon$ was measured at the end of the unloading. No residual strain was observed in Rod 3 (Fig. 4.8).

Figure 4.8: Rod axial strain history.

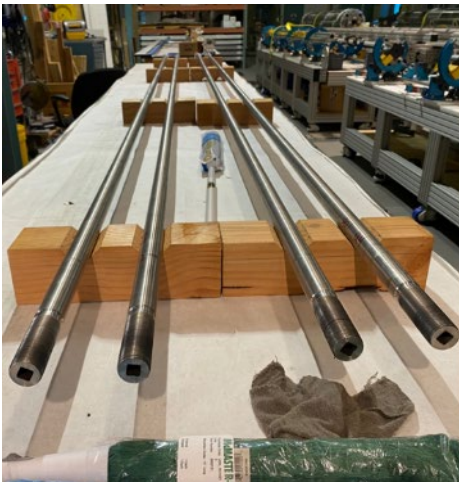
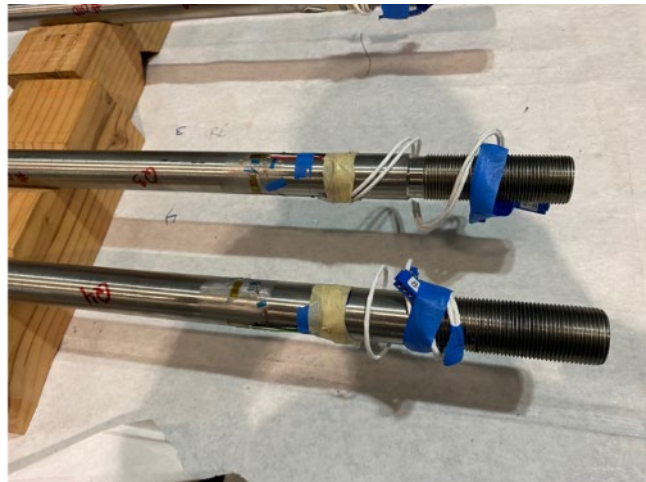
The rods length was not measured prior to the assembly, so a comparison was not possible with the length post-test. Relative lengths after disassembly appears to show that rods 1, 2, 4 each were $\sim 1 \text{ mm}$ longer than rod 3 (Fig. 4.9). However, some variations are expected from the unchamfered rolled threads ends. Therefore, these observations are inconclusive.

Figure 4.9: Rods after disassembly.

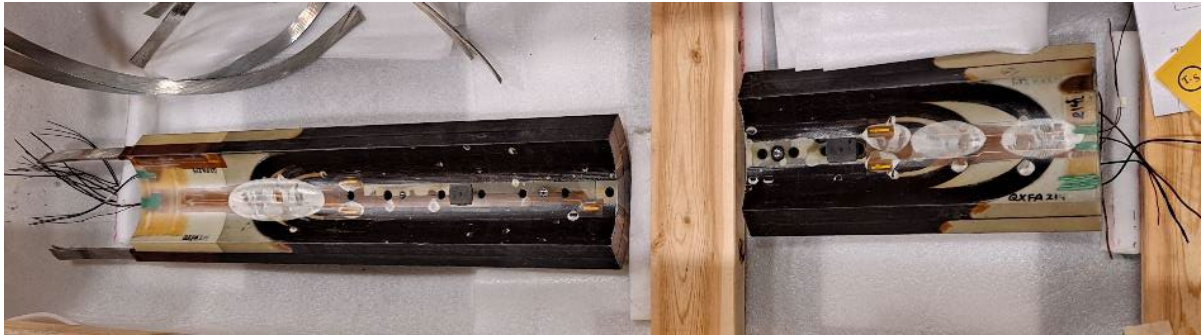
Figure 6.1: Coil 214 Lead (left) and Return (right) ends

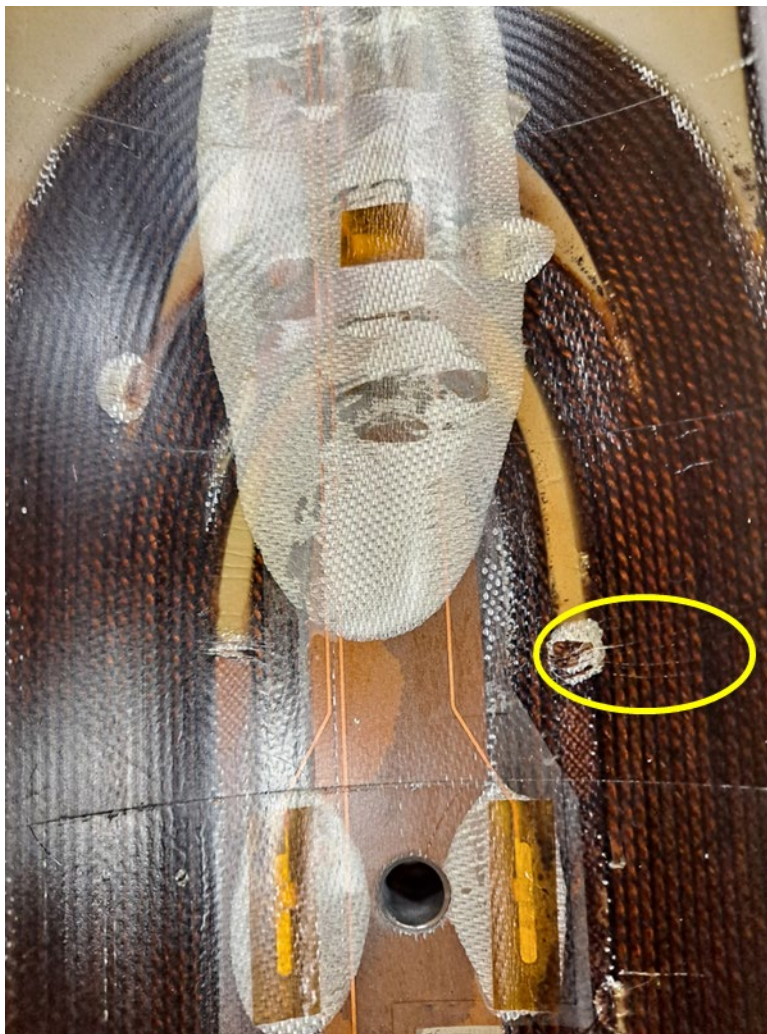
Figure 6.2: detail of coil 214 Lead End. The yellow box shows the position of “scratches” starting from the wedge to end-spacer transition

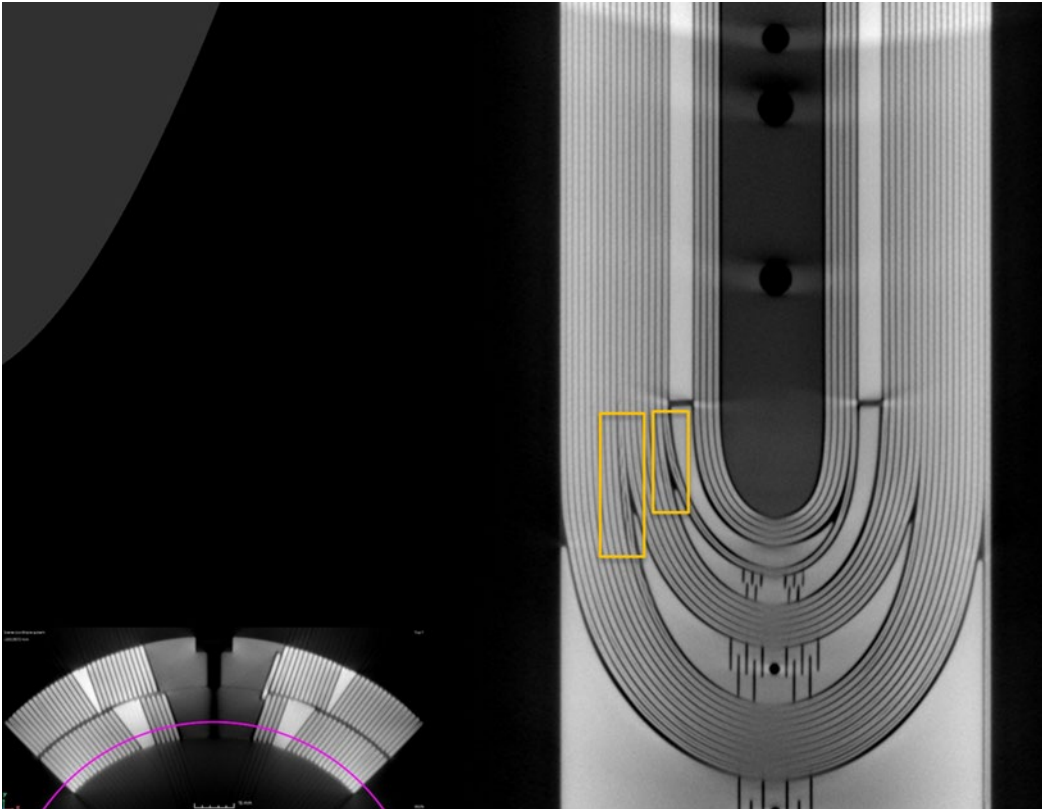
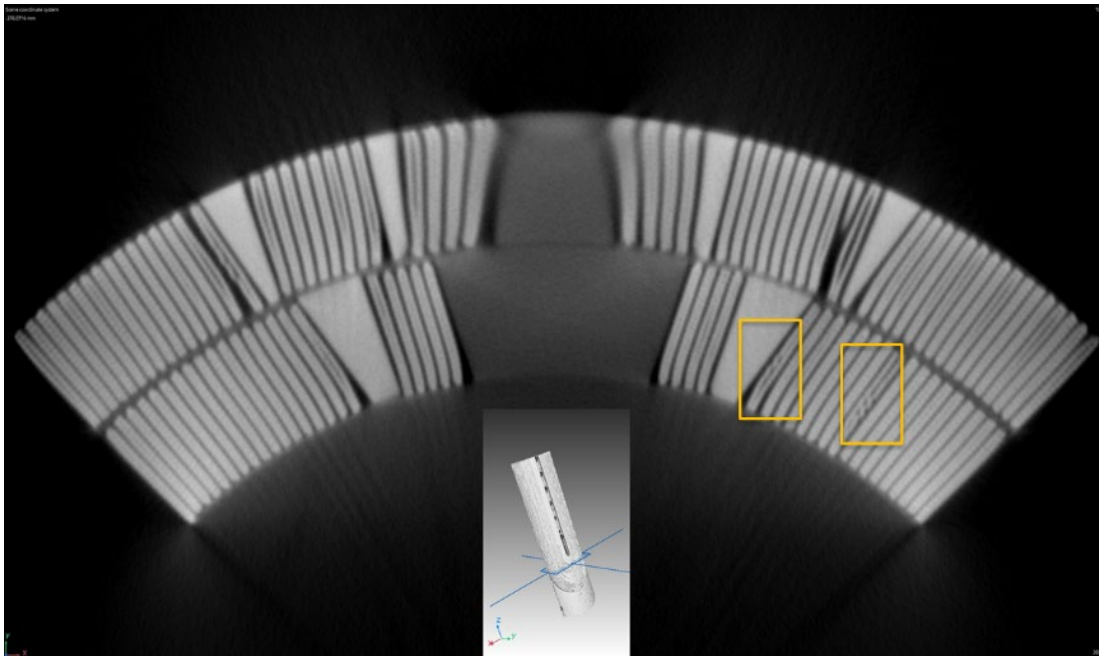
2 shows the number of popped strands found in both ends, taking into account that: *“As one popped in/out strand can induce a wave of events the numbers below show only the amount of conductors affected by the pop in/out effect. So even if there are more than one event in the same cable it is counted as one.”*

Figure 6.3 (Top): Image reconstruction of CT-scan through the Inner Layer of coil 214 Lead End. The purple line on coil cross-section shows the radial position. The yellow boxes highlight the location of two popped strands. The innermost one is within A3-A4 segment. (Bottom): Image reconstruction of coil radial cross-section at the location of the popped strands shown in the top picture.

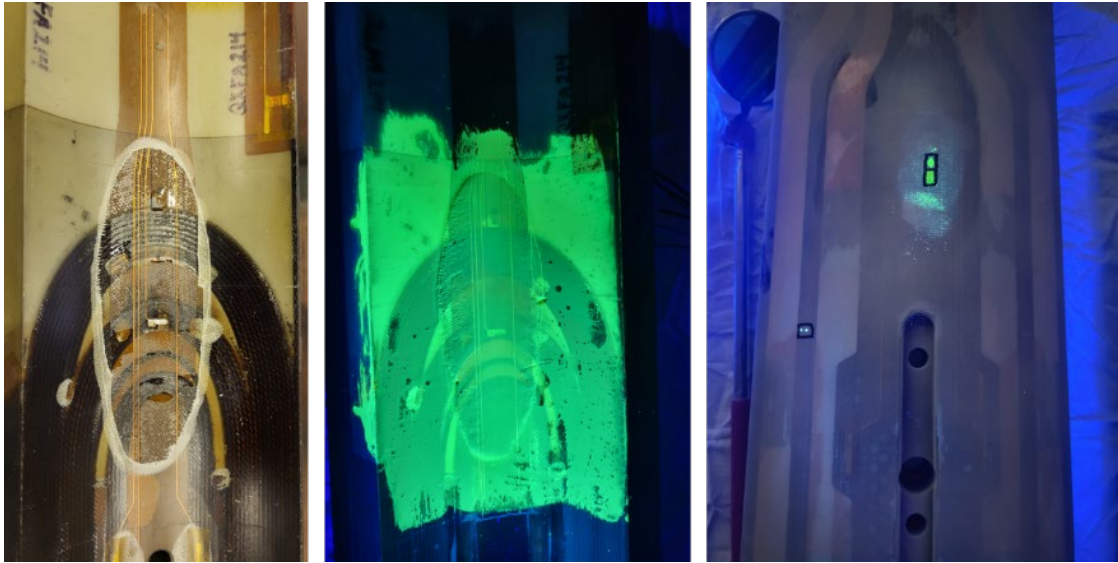
After the CT-scan dye-penetrant test was performed in order to check bonding among coil components. The large bubbles on coil ends were removed by cutting the delaminated insulation (Fig 6.4, left). The dye was applied to the inner radius surface of the coil (Fig 6.4, center) and the outer surface was subsequently examined for signs of paths through the coil (Fig. 6.4, right). Only two small paths were found on the Lead End (Fig 6.5).

Figure 6.4: Procedure and results of dye penetrant test on coil 214 Lead End. The large bubble was removed by cutting the delaminated insulation (left); the dye was applied to the inner surface of the coil (center); the outer surface was subsequently examined for signs of paths through the coil (right).

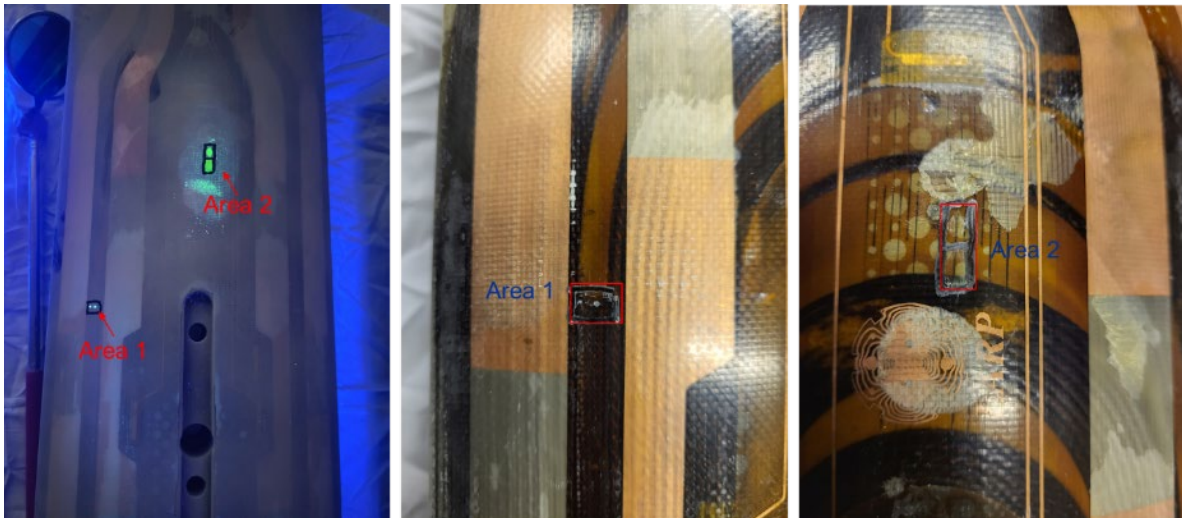
Figure 6.5: Areas where dye emerged on coil 214 outer surface in the Lead End

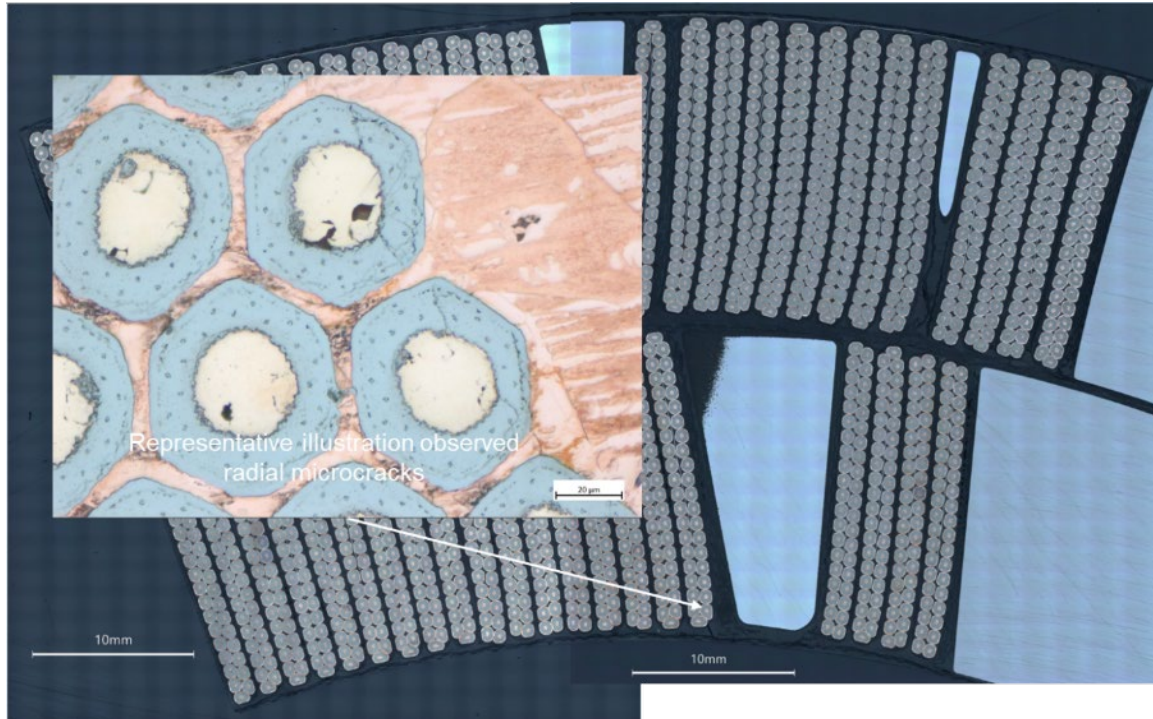
Micrographic analysis of this sample and inspection of superconducting filaments did not show any major event. Some radial “closed” microcracks were observed (Fig. 6.9) as in several other MQXF and Nb₃Sn-magnet cross-sections. These radial microcracks have been found to have no or very limited impact on current carrying capability: FIB-SEM analysis carried out at CERN shown that they are 20-30 μm deep, parallel with respect to the longitudinal axis of strand and not creating a total discontinuity through the SC phase that can still carry current. Other observations: 1) in addition to “usual” shrinkage cavities, some cracks through glass fibers/resin matrix were identified; 2) it was found that ceramic coating on end spacer ensures good cohesion with resin.

Figure 6.9. Example of radial microcracks.

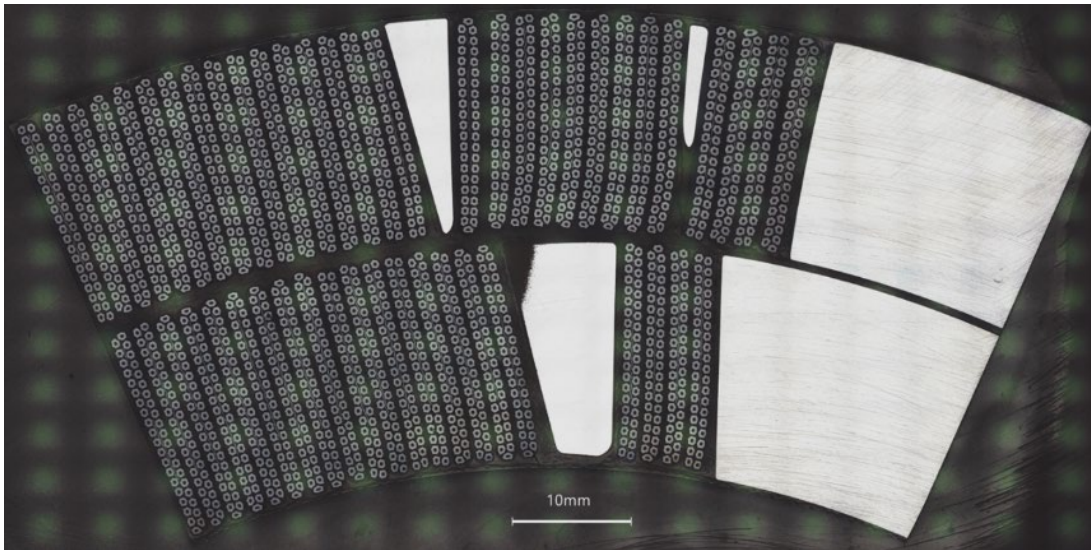
Figure 6.10. Layer jump side of sample 1 after copper etching. No strand exhibited collapsed filaments.

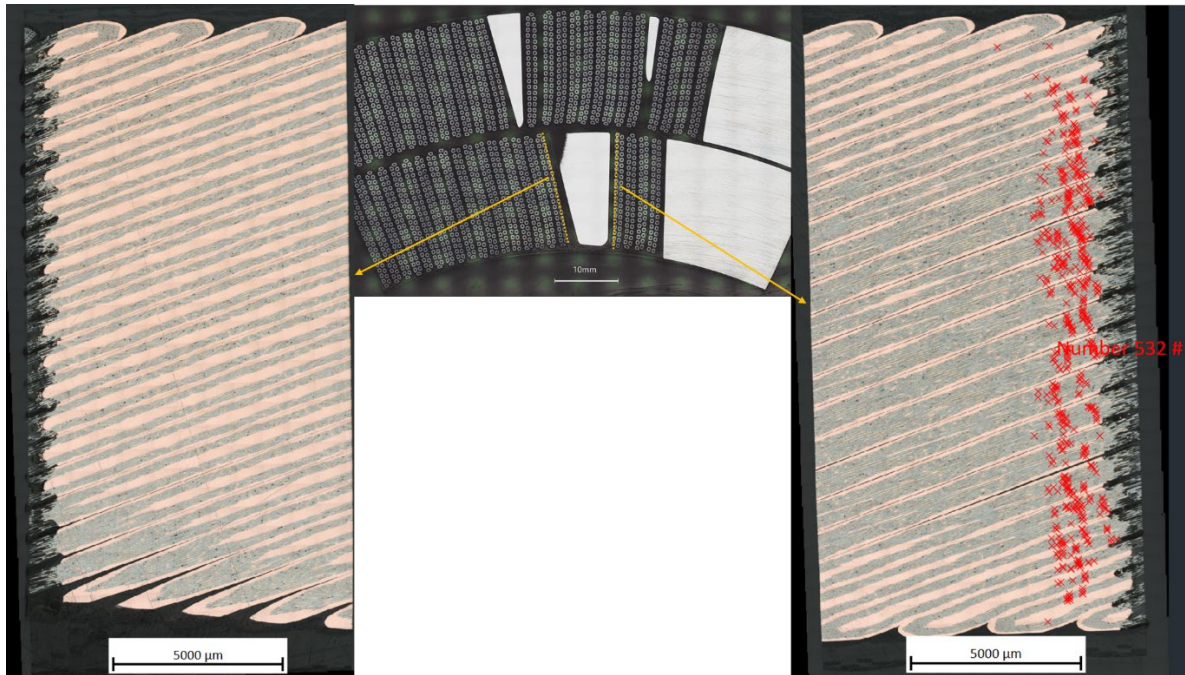
The results of the metallurgical inspection of area 1 are presented in Figure 6.12 - 6.14 and in Table 3. Figure 6.12 shows samples extracted from the layer-jump side, and Figure 6.14 shows samples from the non-layer-jump side. In these figures every red marker indicates a crack in a Nb₃Sn filament (sub-element). Figure 6.12 shows that on the layer-jump side many cracks were found on the cable included in the pole block, whereas no cracks were found in the cable included in the midplane block. Longitudinally, the cracks are concentrated in a narrow section (~ 2 mm wide), and they can be found in all strands on the side of the cable facing the wedge-spacer transition. Figure 6.12 shows a detailed image of some cracks. Figure 6.14 shows that on the non-layer jump side a few cracks (54) were found on the cable in the midplane block, whereas the cable in the pole block had 728 cracks.

Figure 6.12. Metallurgical inspection of cables adjacent to the wedge-spacer transition in the Lead End layer-jump side of coil 214. Each red marker shows a cracked Nb₃Sn filament (sub-element).

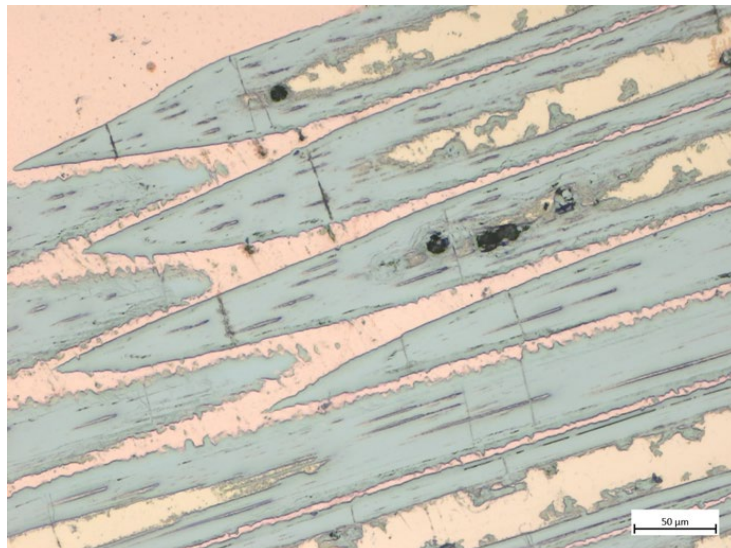
Figure 6.13. Example of some cracks shown in Fig. 6.12.

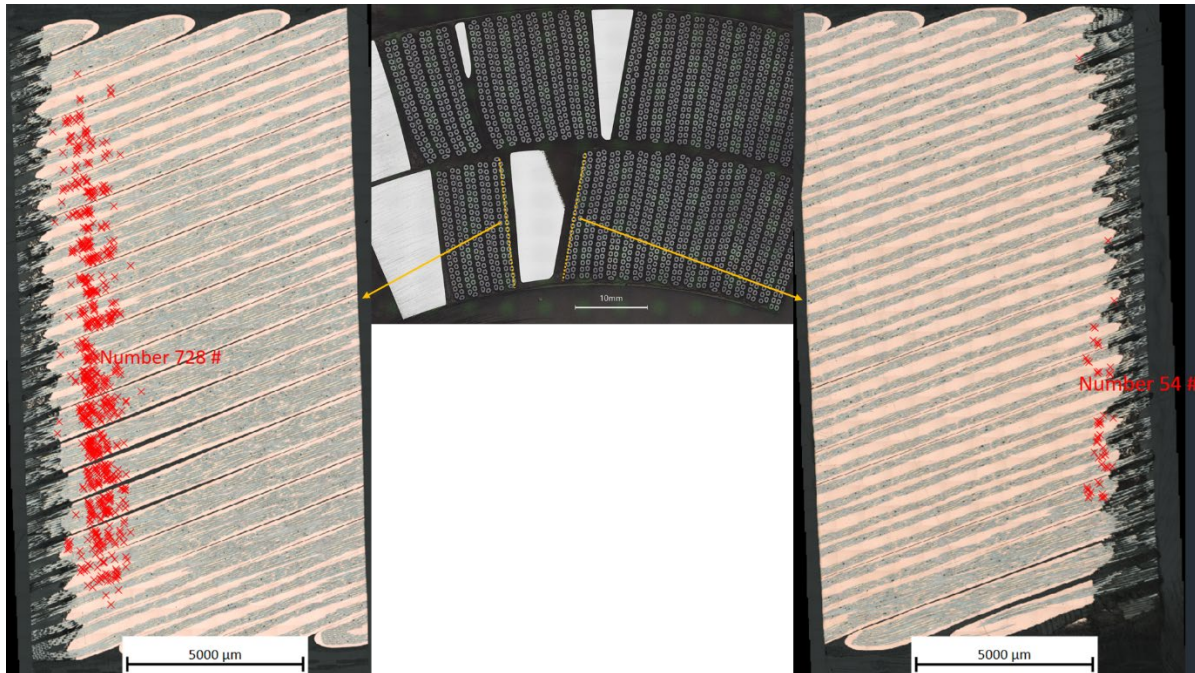
Figure 6.14 Metallurgical inspection of cables adjacent to the wedge-spacer transition in the Lead End non-layer-jump side of coil 214. Each red marker shows a cracked Nb₃Sn filament (sub-element).

In order to assess if there is damage also on the second layer of strands (i.e. on the cable side opposite to the wedge-spacer transition), the same metallurgical analysis was performed also on the second layer of strands in the cable with 728 broken filaments in Figure 6.14. Not a single cracked filament was found on that cable sample.

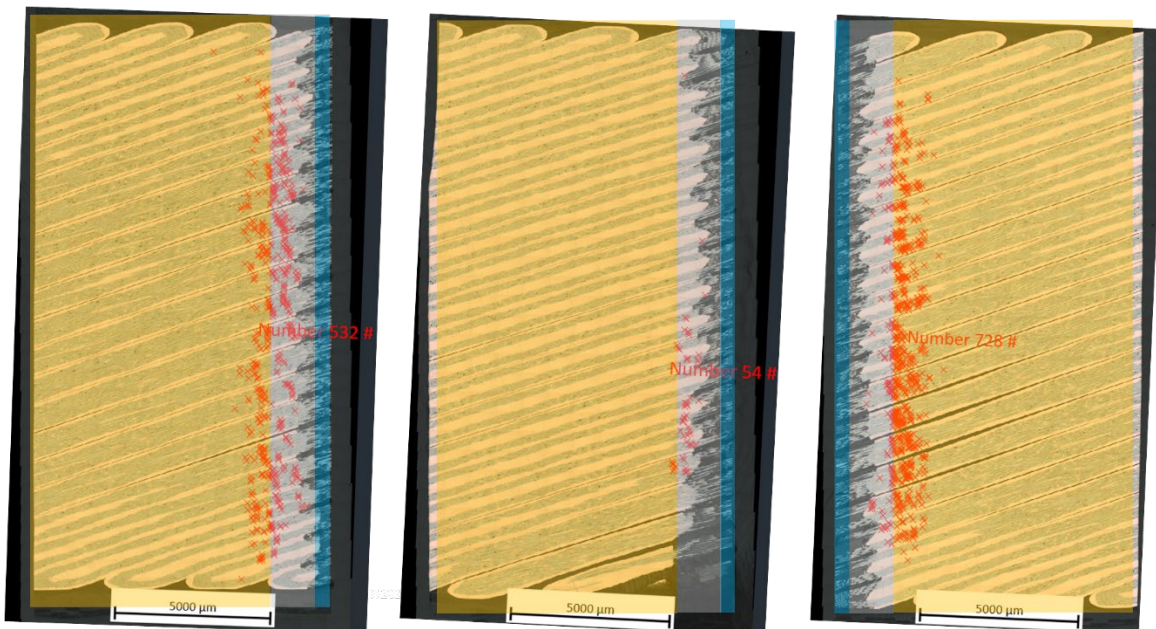
Figure 6.16. Position of filament cracks with respect to the W-S transition. The color scheme is described in the previous figure. Filament cracks are clearly clustered around the transition between the wedge and the resin (filled with S-2 glass).

Figure 6.16 shows that filament cracks are clearly clustered around the transition between the wedge and the resin (filled with S-2 glass). This is consistent with the observation made above that “ceramic coating

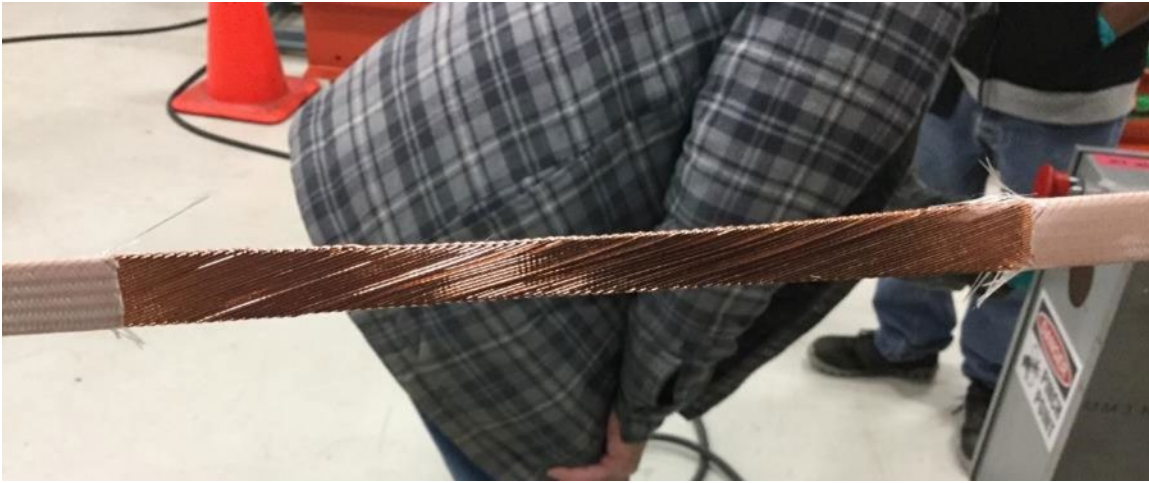
Figure 9.5: Coil 123 roped cable after insulation was removed, and before cable was fixed

Figure 9.6: Coil 123 cable after it was fixed, and before insulation was replaced.
