Analysis of MQXFA07 Test Non-Conformity

US-HiLumi-doc-4293

Date: Sept. 12, 2022

US HL-LHC Accelerator Upgrade Project

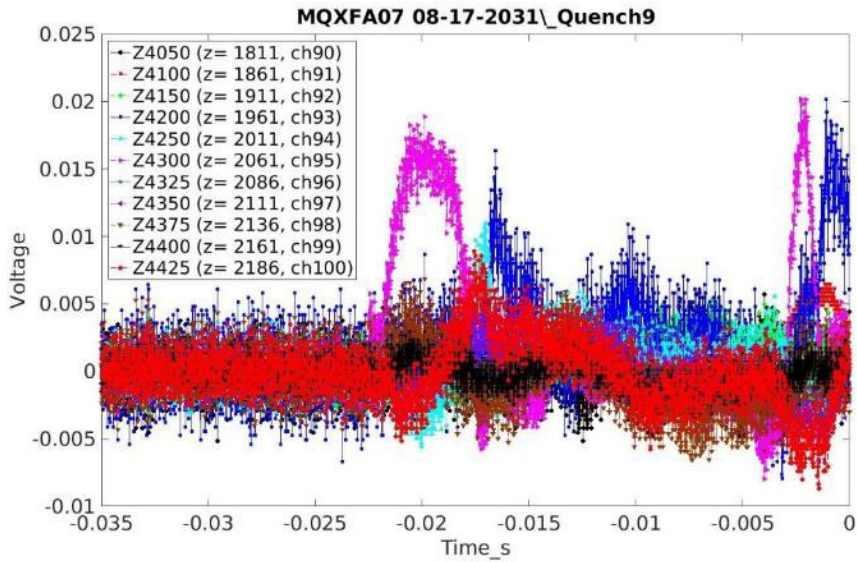
Figure 2.4 shows quench antenna signals (of quench #9) overlapped to a coil drawing. The quench starts at about -23 ms (from quench detection) at the longitudinal position where the turns of the pole-block go around the pole tip. The raw data are shown in Fig. 2.5 for quench 9. The contribution of the last 10 channels of the antenna is displayed. The quench start is detected by channel 95.

Figure 2.5: Signals of the quench antenna from channel 90 to 100 for quench 9 (1.9 K, 20 A/s)

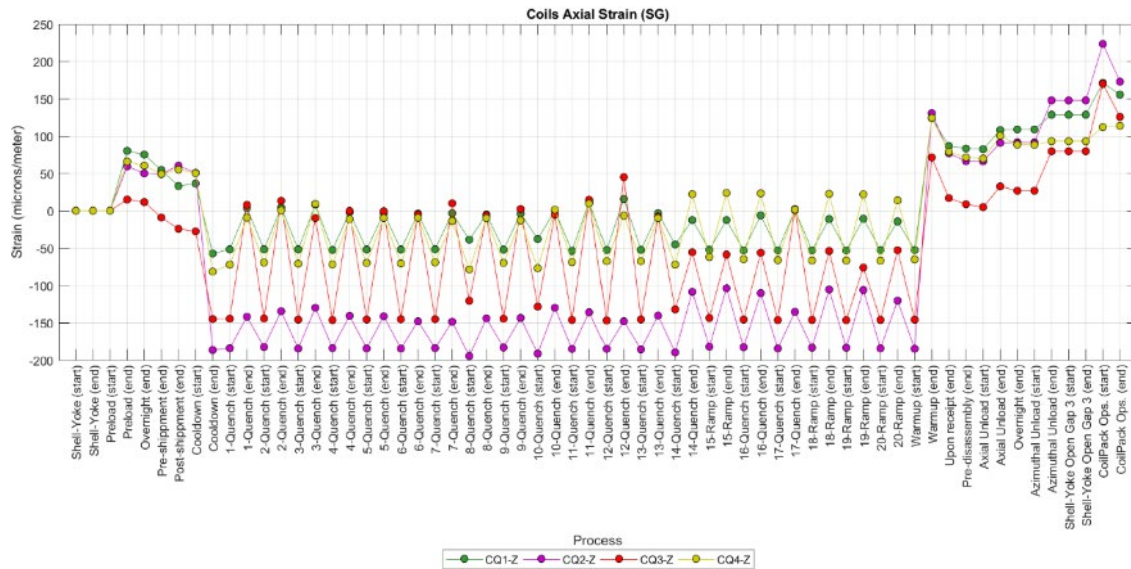
Figure 2.8: Coil axial strain history.

The analysis of the strain gauges was focused in particular on the mechanical behavior of coil Q3 (the limiting coil). The most relevant difference with respect to the other coils was related to coil pole axial strain. As can be seen in Fig. 2.8, where the whole magnet history is plotted, coil Q3 exhibited a lower axial strain at the end of the room temperature pre-loading, and a larger axial strain variation during magnet powering. An analysis of this behavior by mean of finite element simulations is described in chapter 5.

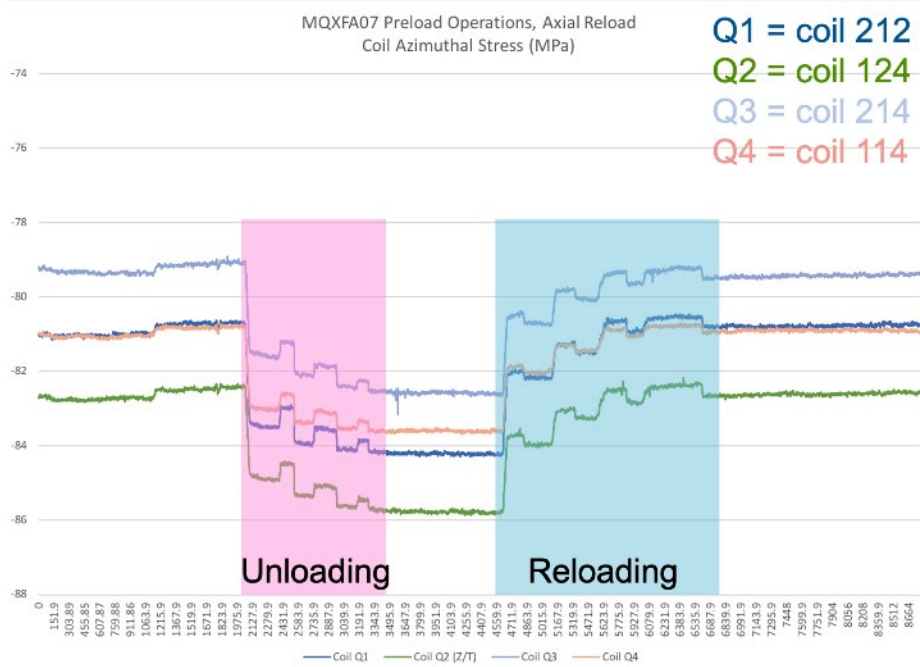
Following preloading, it was noted that the RE axial end plate on MQXFA07 was off-center (shifted down and to the left); to correct this issue, the magnet needed to be unloaded and realigned. The off normal work procedure is documented in docDB-4210 and MQXFA-NCR-0220 and is similar to work done on MQXFA06 NCR-164. The following corrective actions were taken:

Figure 3.4: Coil azimuthal stress during off-normal work procedure for MQXFA07 NCR-220

1. Unload ~50% of the load (to ~470 $\mu\epsilon$)
2. Check strain gauges to verify repeatability
3. If numbers are proper, reduce force to light contact (~50 $\mu\epsilon$) to maintain friction
4. Move RE endplate using bracket tooling and align (same tooling as used on MQXFA06)
5. Reload to 950 $\mu\epsilon$ rod strain
6. SG readings maintained throughout process
7. Verify SG readings are ok

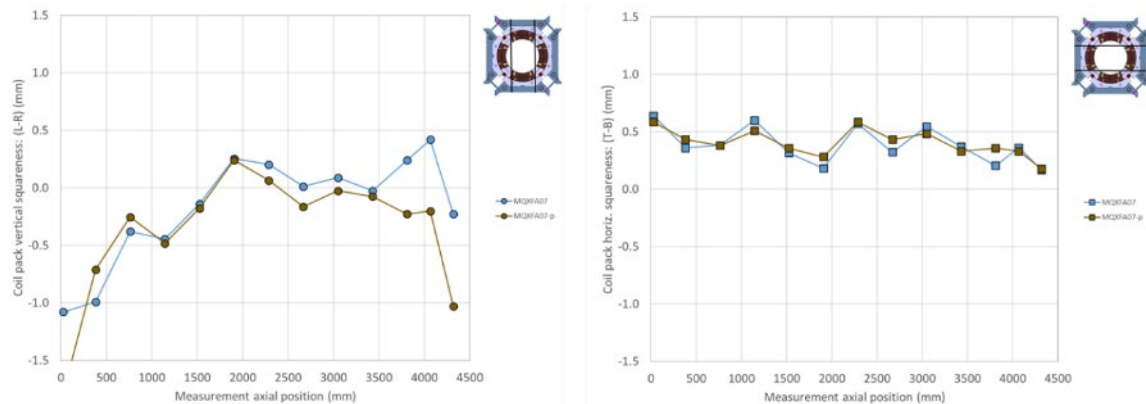
Figure 4.2: Coil-pack squareness measurements before the test (A07) and after the test (A07p).

This variation corresponds to a change in coil outer radius of -0.100 to 0.150 mm, or a change in coil arc length of -0.150 to -0.235 mm. The coil-pack size profile did not change, and maintained a significant size reduction in correspondence of the magnets ends. Also, the squareness measurements indicated that the coil pack did not change from before to after the test (see Fig. 4.2), and kept a trapezoidal shape, shown by the difference between the top (T) and bottom (B) horizontal measurement (Fig. 4.2 right).

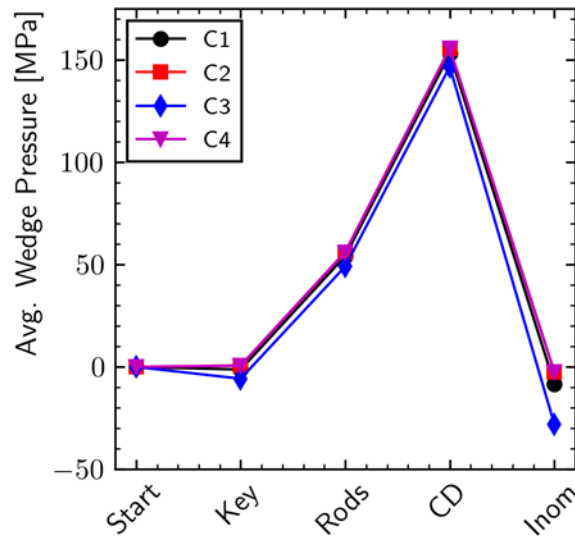
If now we focus on the contact area between the wedge and the end spacer in layer 1, we see that, if we assume that all the coil surfaces are bonded, a tension occurs in quadrant 3 during excitation, as shown in Fig. 5.5. More precisely, when Lorentz forces are applied, the average tension between wedge and end-spacer is about 30 MPa in quadrant 3, while it remains close to zero in the other quadrants.

Figure 5.5: Average contact pressure (negative in tension) between wedge and end-spacer in the bonded case.

In summary, a higher tension between the spacer and end-shoe is observed in the Q3 due to the lower azimuthal and axial pre-load caused by the closed pole key gap. The higher tension results in a higher possibility of epoxy cracking between the wedge and the end-spacer.

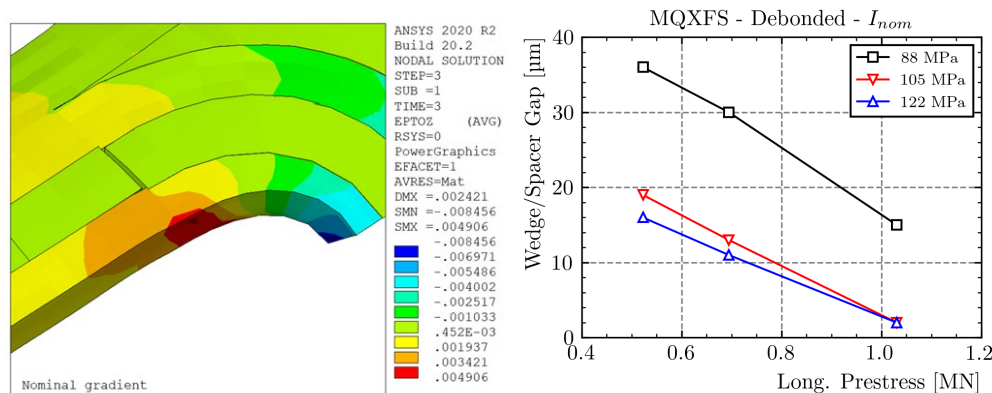
The impact of a possible separation between the wedge and the end-spacer on the coil strain was studied with an octant model, which allows a more refined mesh compared to the 360 degrees model. Under the assumption that the coil surfaces are not bonded, i.e. that epoxy cracking has occurred, the gap between wedge and end-spacer, showed in Fig. 5.6 (left), increases with progressively lower azimuthal and axial pre-load, i.e. the conditions of Q3 in the MQXFA07 scenario according to the 360 degrees 3D model. The gap induces a spike in axial strain in the coil, which can reach the 0.4% level (see Fig. 5.7, left). As can be seen in Fig. 5.7, right, a larger increase is computed in the turn towards the pole.

Figure 5.6: Left: View of the gap between wedge and end-spacer in the no-bonded case. Right: variation of the gap as a function of the azimuthal and axial pre-load.

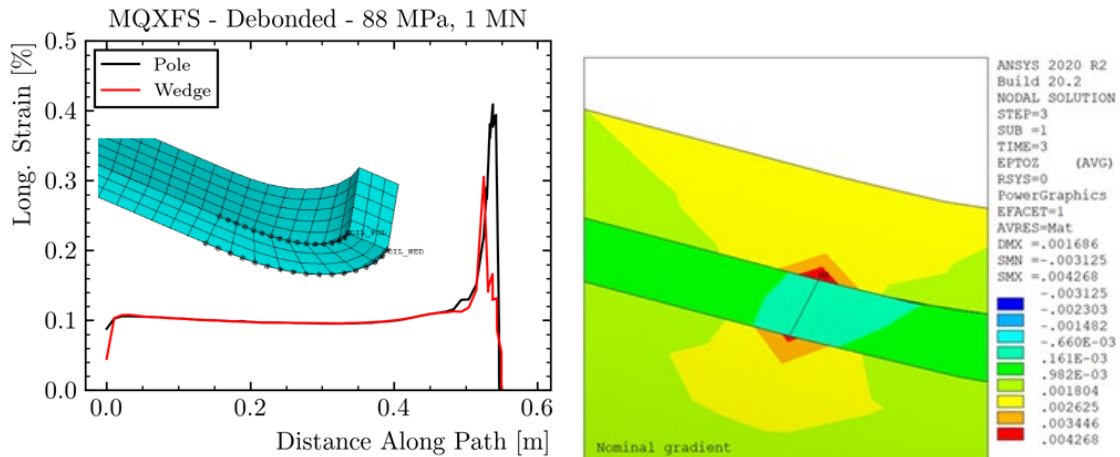
Figure 5.7: Left: Analysis of coil axial strain (pole block) in correspondence of the transition zone from end-spacer to wedge. Right: view of the increase in axial strain close to the gap in the pole block (top) and mid-plane block (bottom).

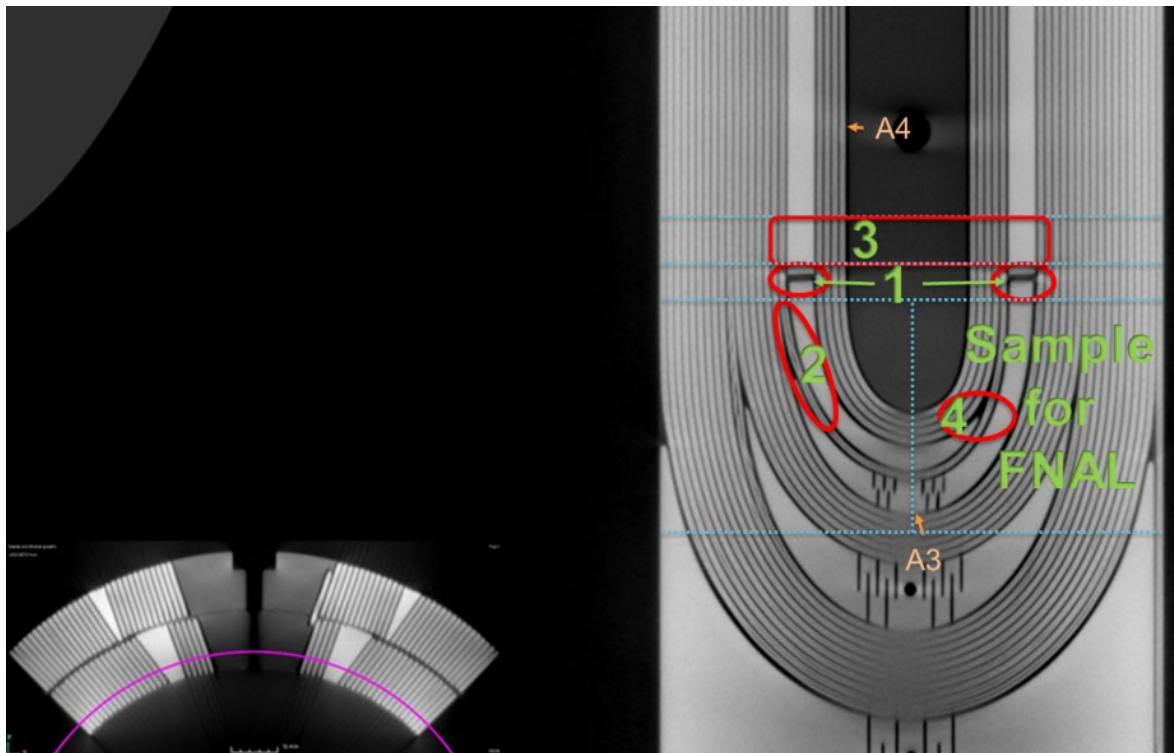
Based on CT-scan results it was decided to perform macrographic analysis of 4 regions of the Inner Layer of coil 214 lead end. These regions are shown in Figure 6.7 and described below:

1. This is the wedge to end-part transition on both coil sides. The FE analysis described in section 5 has shown the possibility of strain concentration in this region due to the unusual elongation of coil 214 because of the closed gaps. Both visual inspection (Fig. 6.2) and die penetrant tests (fig. 6.6) showed signs of strain concentration in these regions. According to FE analysis, the cables most affected by this mechanism should be those on both side of each wedge to end-spacer transition.

2. This is the area where tomography showed a turn affected by popped strand(s) within the limiting segment (A3-A4). Micrographic analysis of this area is particularly challenging because the cable is not straight.
3. This is the area where the last collar lamination in contact with the pole-key ends. In case of sliding between this collar lamination and the next one (not supported by the pole-key) there could be a stress gradient in this region.
4. This is the tip of the end-spacer allowing turn 5 to move from the pole block to the mid-plane block. It is the other transition within the limiting segment (A3-A4). This sample was sent to Fermilab.

Figure 6.7. Areas in coil 214 Inner Layer Lead End selected for micrographic analysis.

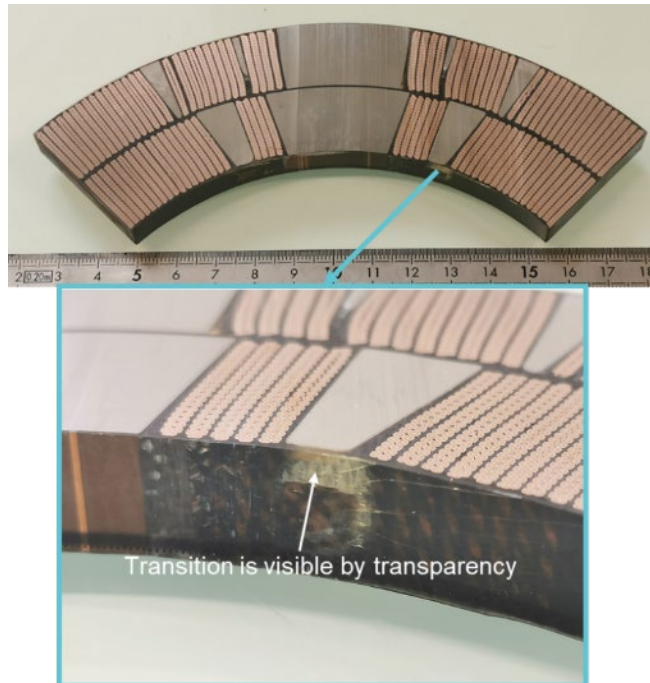
The sample cut for micrographic analysis of area 1 is shown in Fig. 6.8. It is 10 mm thick and was ground and polished to approach the interface.

Micrographic analysis of this sample and inspection of superconducting filaments did not show any major event. Some radial “closed” microcracks were observed (Fig. 6.9) as in several other MQXF and Nb₃Sn-magnet cross-sections. These radial microcracks have been found to have no or very limited impact on current carrying capability: FIB-SEM analysis carried out at CERN shown that they are 20-30 μm deep, parallel with respect to the longitudinal axis of strand and not creating a total discontinuity through the SC phase that can still carry current. Other observations: 1) in addition to “usual” shrinkage cavities, some cracks through glass fibers/resin matrix were identified; 2) it was found that ceramic coating on end spacer ensures good cohesion with resin.

Figure 6.8. Sample for analysis of wedge to end-spacer transition

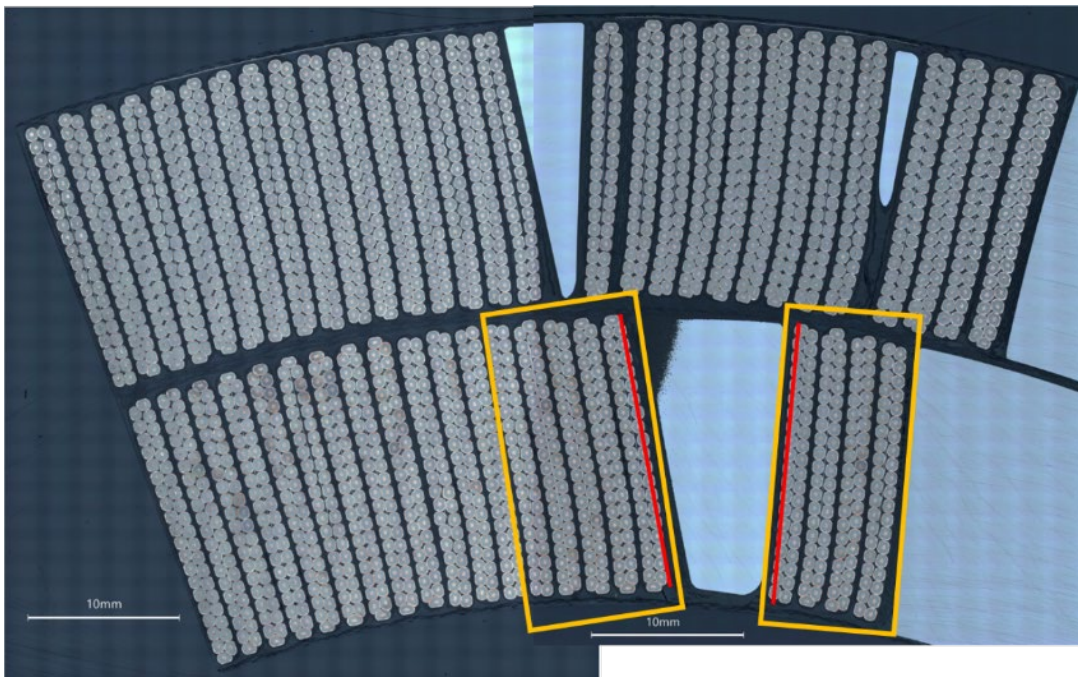
In order to assess strand integrity along the whole transition it was decided to extract smaller samples (yellow boxes in Fig 6.11) and to perform longitudinal cuts on the 2 cables facing the wedge to end-spacer transition on both coil sides (i.e. 4 cables total). The longitudinal cuts are to be performed along the cable side facing the transition (red lines in Fig. 6.11).

Figure 6.11. Plan for longitudinal cuts along wedge to end-spacer transitions

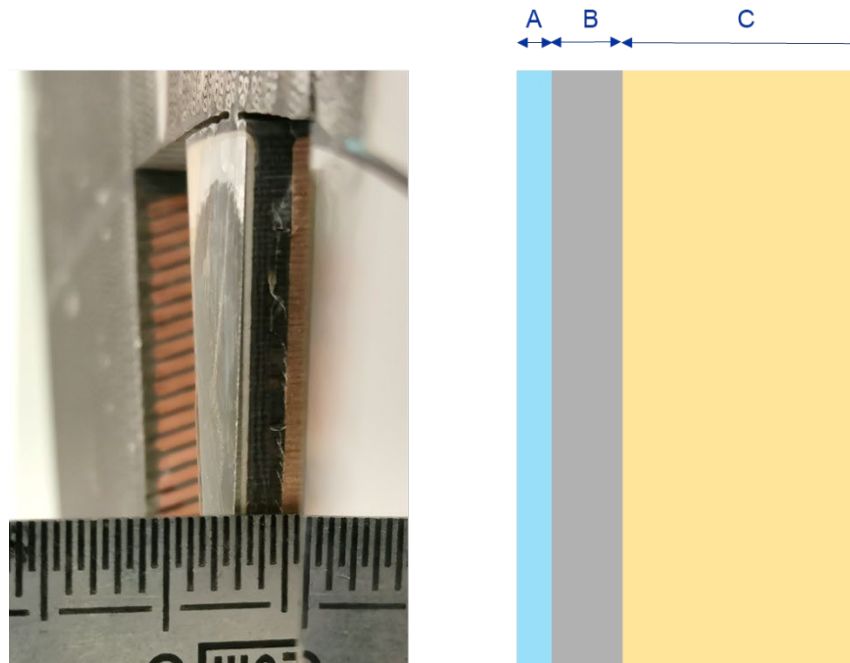
The detailed position of the cracks with respect to the wedge-spacer transition is shown in Figures 6.15 and 6.16. Figure 6.15 shows the color scheme used to show the position of filament cracks with respect to the W-S transition in Figure 6.16: A (light blue): End spacer + ceramic coating $\approx 0,5$ mm; B (grey): resin (filled with S-2 glass) between end spacer and wedge $\approx 1,5$ mm; C (light yellow): copper wedge.

Figure 6.15. Left: coil section shown in Fig. 6.8 after samples were extracted for metallographic inspection. Right: color scheme used to show the position of filament cracks with respect to the W-S transition in the following figure. A: End spacer + ceramic coating $\approx 0,5$ mm; B: resin (filled with S-2 glass) between end spacer and wedge $\approx 1,5$ mm; C: copper wedge.

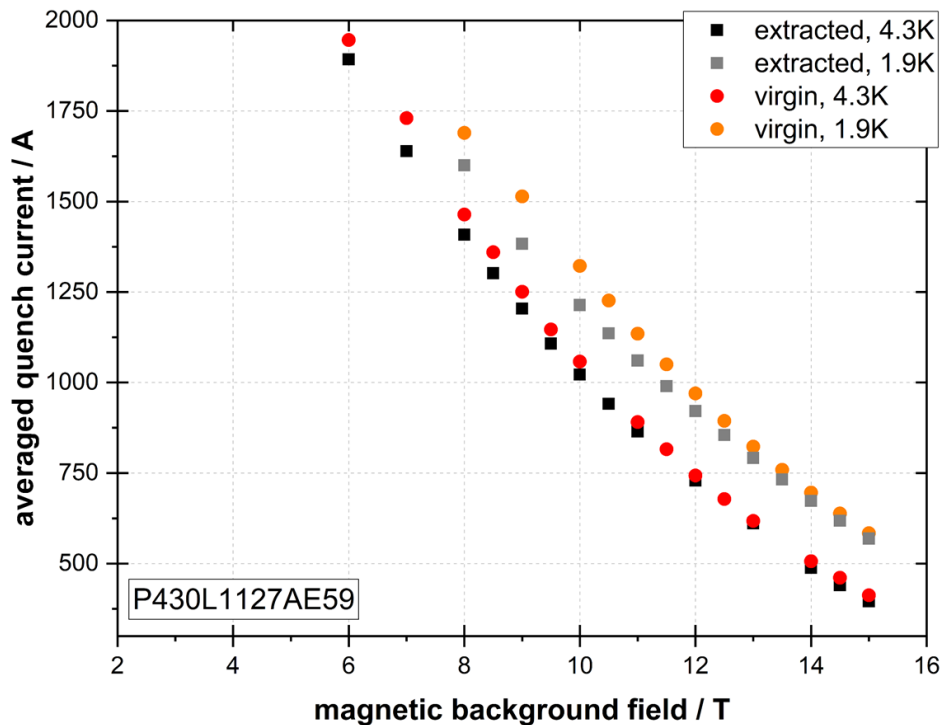
The figures below show measurement results. No sample showed sign of stability issued up to 2 kA.

Figure 9.1. Samples: P430L1127AE59 extracted & virgin

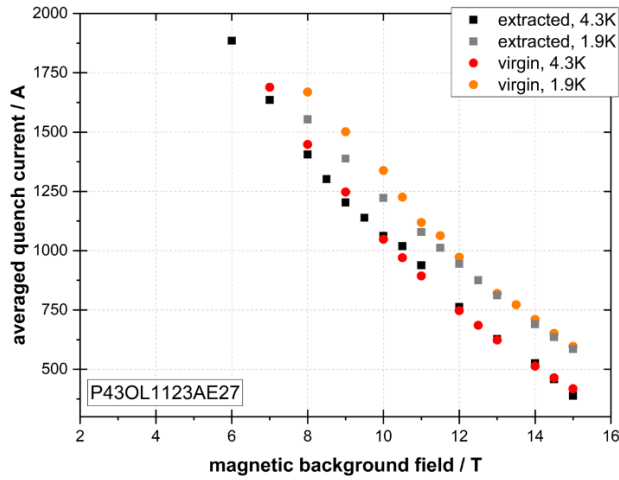
Figure 9.2. Samples: P43OL1123AE27 extracted & virgin

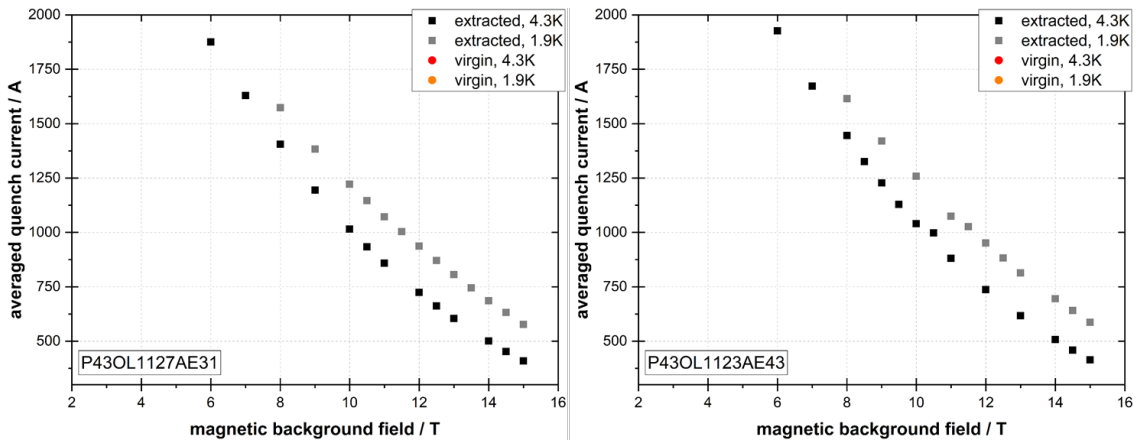
Figure 9.3. Samples: P43OL1127AE31 extracted (left) & P43OL1123AE43 extracted (right)

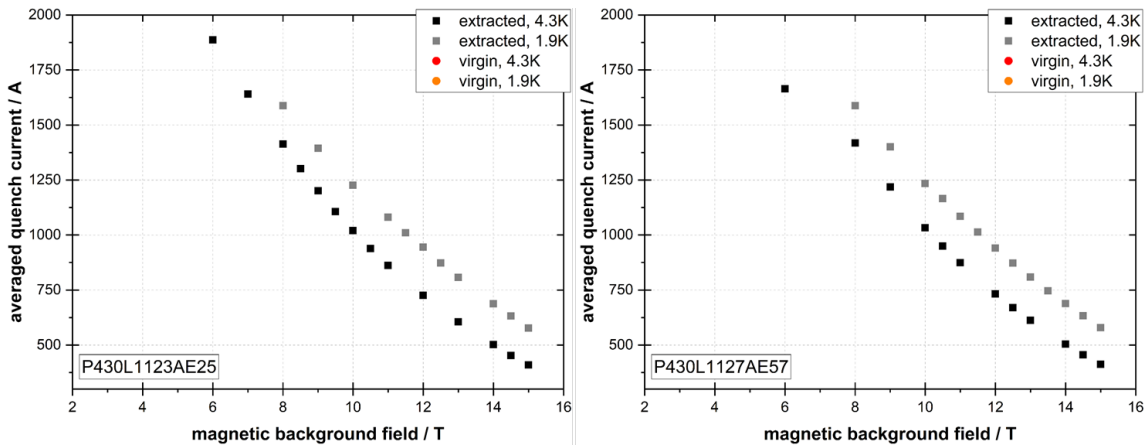
Figure 9.4. Samples: P43OL1123AE25 extracted (left) & P43OL1127AE57 extracted (rights)
